A Laboratory Study on the Failure of a Petroleum, Oil and Lubricant (POL) Fuel Tank

DSTO-TN-0300

**Combatant Protection and Nutrition Branch
Aeronautical and Maritime Research Laboratory**

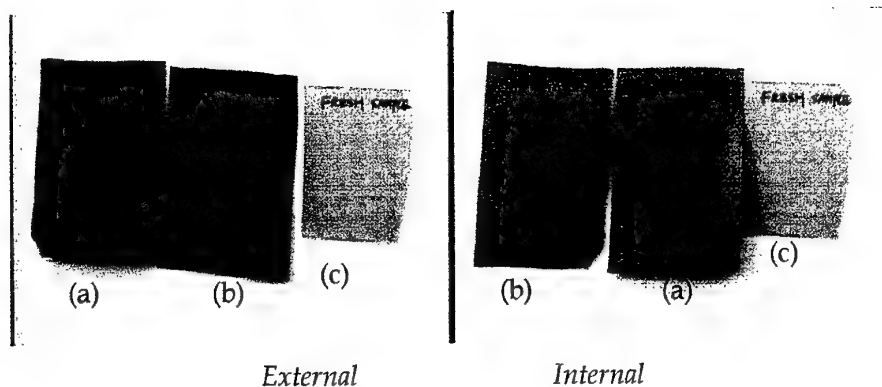
Undamaged samples and samples from undamaged areas of the POL tanks were exposed in the Xenon arc weatherometer for periods ranging from 9 weeks for the undamaged sample and 5 weeks for samples from the POL tanks. Although the samples were exposed to both Xenon light and high humidity (water spray), apart from a change in colour, they showed no evidence of degradation. As shown in Table 2, IR analysis did not indicate any significant loss of ester moiety from the coating material. Figure 5 shows the rear and front faces of the internal and external surfaces of the tank after exposure to Xenon weathering. A sample of unexposed fabric is included for comparison.

Figure 5. POL tank samples after 5 weeks Xenon light and water exposure (a) rear surface, (b) exposed surface and (c) unexposed sample

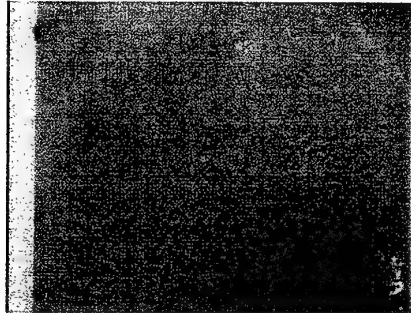
Figures 7, 8 and 9 show the samples following exposure of 4, 6 and 12 weeks respectively in the hot and humid environment within the desiccator. Figure 7 displays visual evidence of water damage and Figure 8 shows the failure of the coated samples after 6 weeks exposure. Figure 9 shows that the sample was completely degraded after 12 weeks with cracks and delamination similar to the damaged areas observed in the in-service POL tanks. This suggests that a combination of a high temperature and high humidity over a period of time is necessary to completely hydrolyse the coating. This is reinforced when the visual appearances between a fresh sample and a sample exposed for 12 weeks in the dry environment within the

Figure 7. Sample after 4 weeks hydrolysis at 80°C and 100%RH

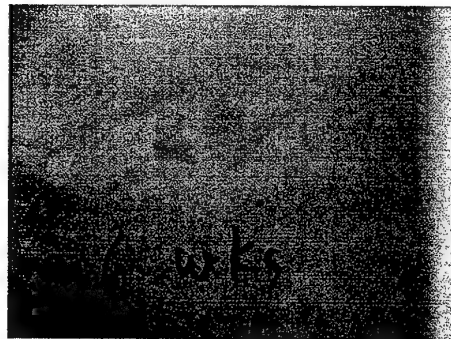
Figure 8. Sample after 6 weeks hydrolysis at 80°C and 100%RH

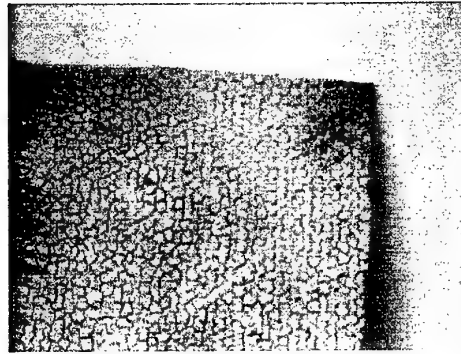
Figure 9. Sample after 12 weeks hydrolysis at 80 °C and 100%RH

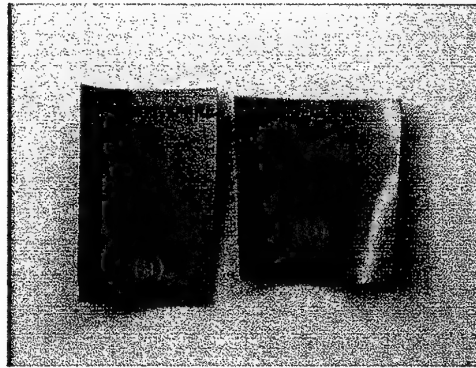
After immersion in diesel fuel for 3 weeks the samples showed a slight visible colour change (Figure 11). No cracks or delamination could be detected.

Figure 11. Unexposed coated fabric and coated fabric sample after 3 weeks immersion in diesel fuel (a) unexposed, (b) after immersion in diesel fuel
